# RaiseTech W50 mining drilling machine

## The Application

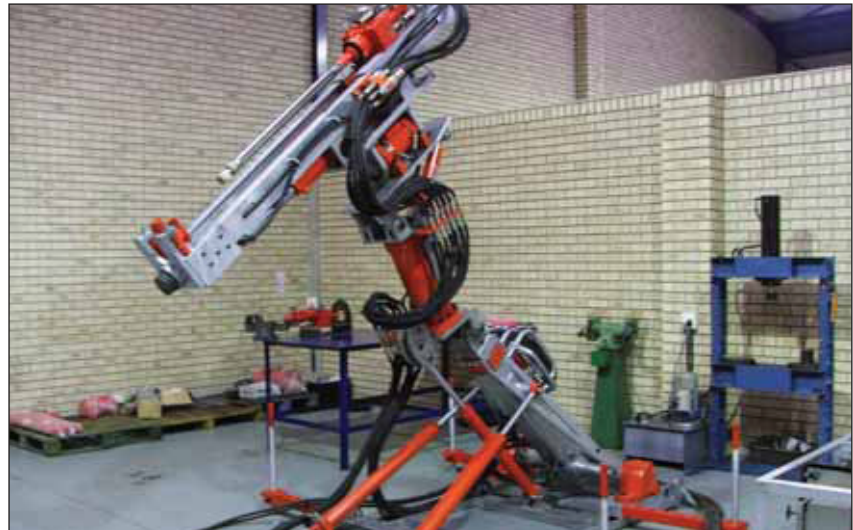
The hot dip galvanized prototype rock drilling machine as supplied.

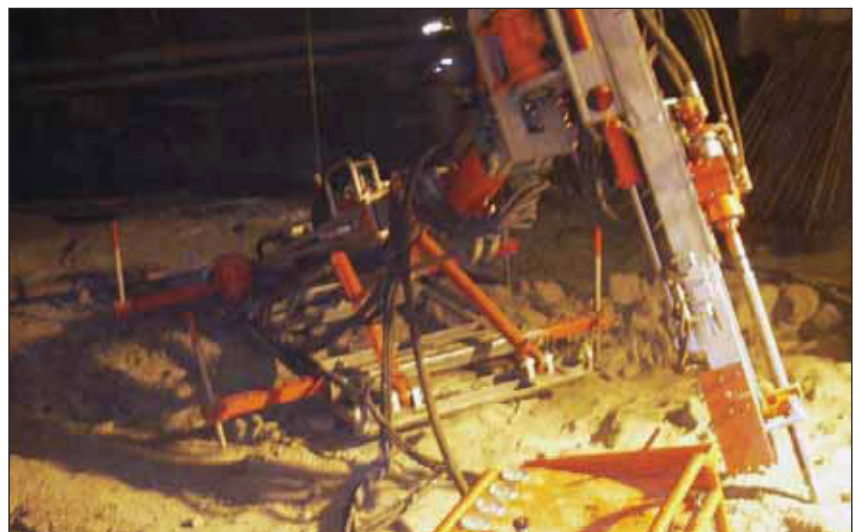
The machine in operation.

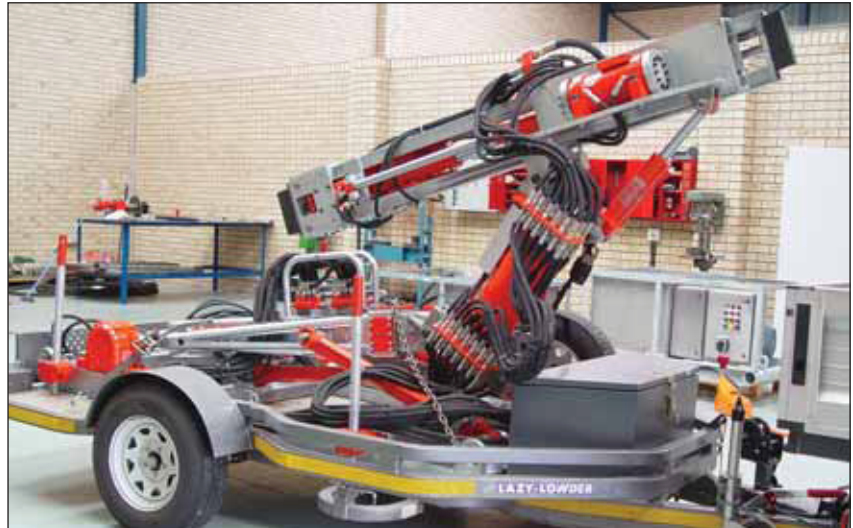
Mobility of the equipment, to the mine site as well as underground, was an important feature and therefore incorporated into the design.

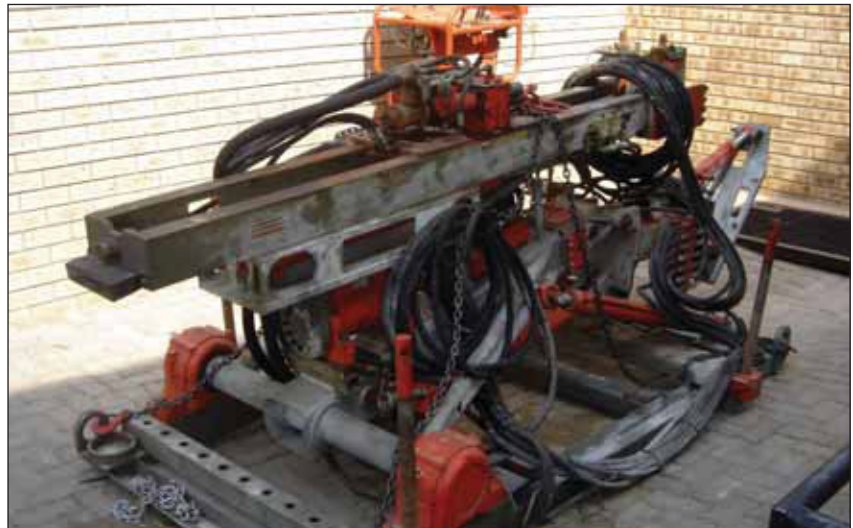
The hot dip galvanized steel components were standing up to the condition extremely well with no discernable deterioration. Comparisons to painted and uncoated components on the machine, clearly demonstrated the differences in corrosion control performance. Early performance indications were very encouraging and that potential economic benefits could be significant.

Photograph taken of the drilling machine after 4 months operational conditions, illustrating the comparisons between uncoated bolts, painted surfaces and the hot dip galvanized machine components.

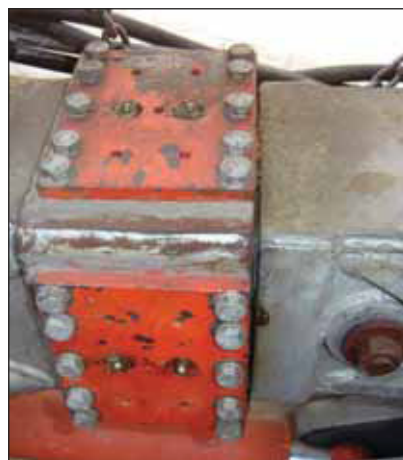
Where hot dip galvanized fasteners were used the comparison to uncoated fasteners is clearly evident.

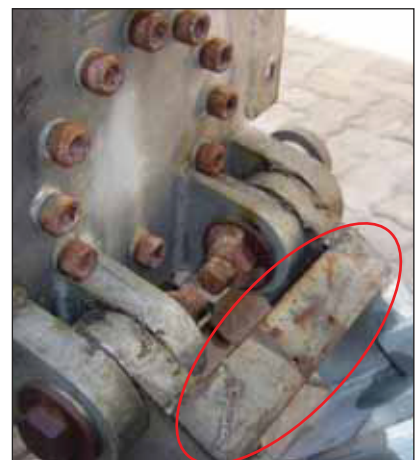
Steel components, added after hot dip galvanizing were silver painted, again illustrating the corrosive effect relative to the hot dip galvanized surfaces.
